USAAEFA-80-14

USAAEFA PROJECT NO. 80-14

**LIMITED ARTIFICIAL AND NATURAL ICING TESTS
PRODUCTION UH-60A HELICOPTER
(RE-EVALUATION)**

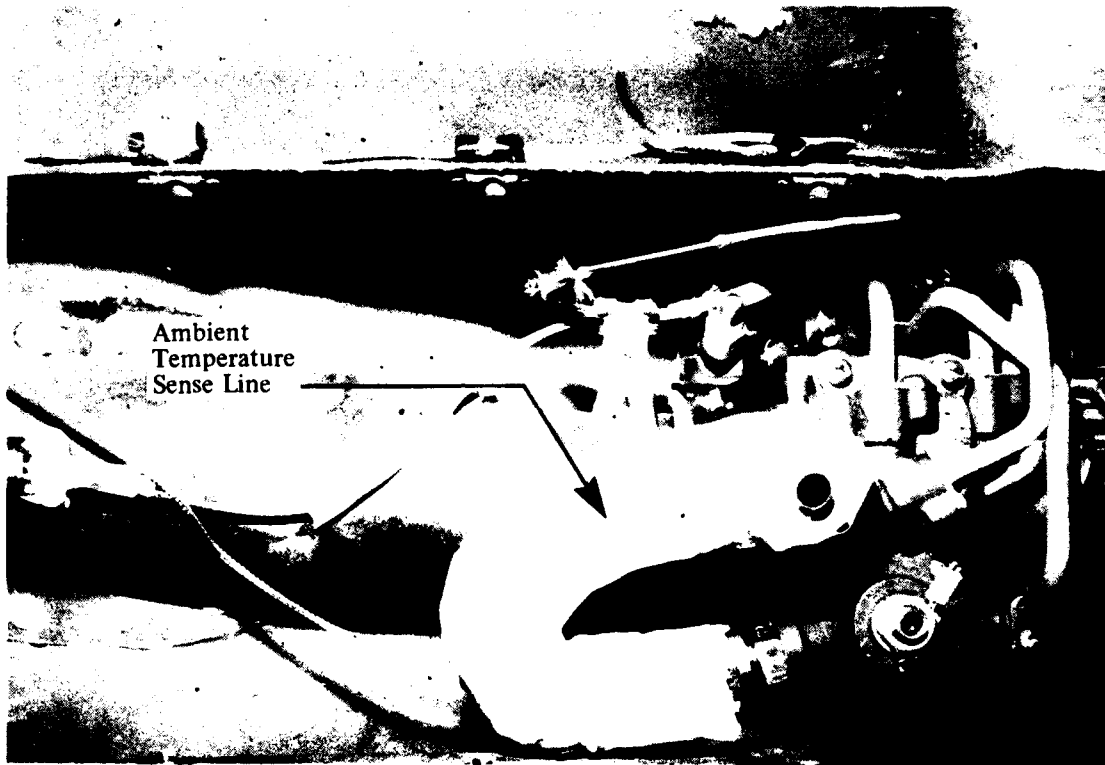
12. The major difference between anti-ice systems from previous icing tests (ref 3, app A), was the engine inlet anti-ice valves (app B). The test engine inlet anti-ice valves modulated the amount of compressor bleed air to the inlets based on ambient air temperature sensed through a temperature air sense tube (photo 1, app G). All anti-ice systems were activated prior to entering the icing environment and were operational for all icing flights. All observed anti-ice system operational characteristics were identical to previous tests except as noted in the following paragraphs.

Photo 1. Engine Inlet Anti-Ice Valve with Insulated Ambient Temperature Sense Line
